On this day, June 24, 2011, at approximately 7:35 pm, I witnessed the crash of a Beechcraft Bonanza with a registration number reading 88MN. This was determined from the post crash wreckage before police arrived. Observing from the terminal, I watched as the Bonanza executed what appeared to be a missed approach over runway 27. This was the general consensus between myself and Ken Slough judging from the sound of the aircraft. Shortly after the aircraft began a missed approach, it reduced power suddenly. At this point I assume that they had sighted the runway and were attempting to continue with the landing. The aircraft descended suddenly and began to lower its gear at approximately 200-300 feet AGL. Apparently realizing the airport could not be made, the aircraft then began a left hand turn at about the height of the water tower and directly behind it from my vantage point. The aircraft then began a tight right hand turn, crossing over the approach end of runway 9 and at this point was barely visible and occasionally obscured completely. The pilot at this point made a radio call for downwind for runway 27. The aircraft appeared again from the west at about ¼ mile or less to the n

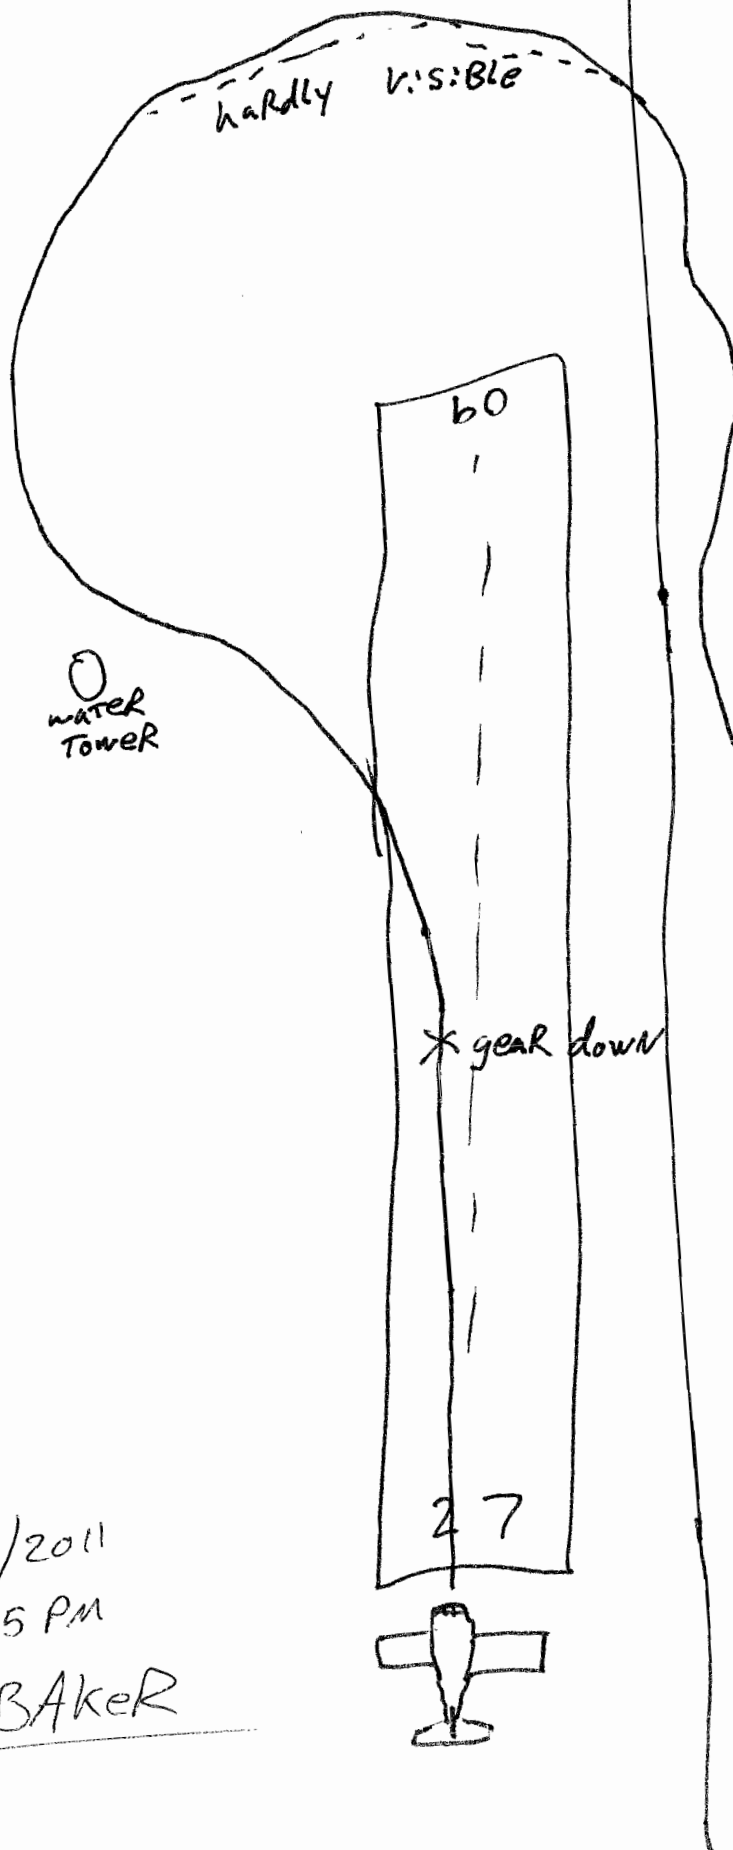
← Apparent decrease in ~~altitude~~ Airspeed

← hard Right TURN

← Stall (100 FT)

* CRASH site
